# Coiled Tubing Inspection

Inspection Note 7 – rev 3 / Oct. 2002

Steve Papadimitriou – STYLWAN

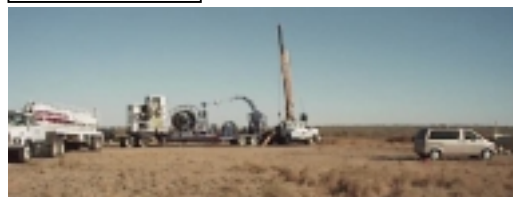
Coiled Tubing (CT) failures generally occur due to: a) Random Mechanical Damage (MekDmg  $\approx$ 25%); b) Corrosion pitting (PIT  $\approx$ 30%); c) Fatigue (FTG  $\approx$ 5%); d) Manufacturing and Handling induced damage (Mfg/Hndl  $\approx$ 10%); e) Errors and omissions (Err  $\approx$ 15%) and f) miscellaneous Other reasons (Other  $\approx$ 15%).

Where CT inspection is concerned, general failure charts, such as the one above, are meaningless because they portray the CT failure causes as viewed by a certain organization or even a single individual over an undefined geographical area and CT deployment. On the other hand, CT inspection must always be focused to the specific application in the specific geographic area. For example, North Sea workover CT failures are mostly unrelated to production coil failures in Alberta Canada or to CT pipeline failures in the Gulf of Mexico.

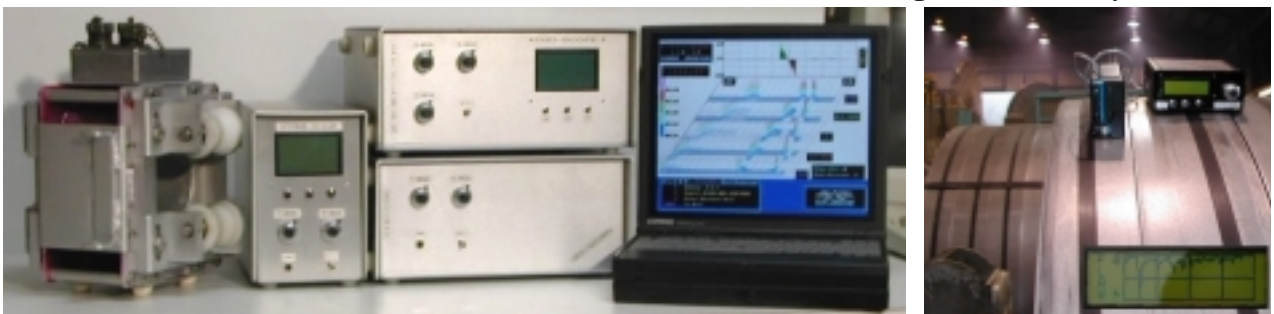
3D inspection head with 3.5” ID clearance, **Dynamic 3D-Scan (CoilScan)**, **Dynamic 3D-Scope (CoilScope)** – on the Top), **3D-Scan** (Bottom) and **PC** (Readout & Storage). **SkelpCheck** on the right.

The field configuration of the STYLWAN Three-Dimensional Finite Element Inspection (3D-FEI) equipment is always focused for the specific application through the ***Inspection-Profile*** that fine-tunes the ***imperfectionDNA*** through **MULTISLOPE** techniques.
